Analysis of Brownfields Cleanup Alternatives and
Cleanup Work Plan
New England Youth Theatre
48 Elm Street
Brattleboro, Vermont 05301

EPA Brownfields RFA 19093
Vermont DEC Site #2008-3834

March 25, 2021

Brownfields Phase II ESA Report
New England Youth Theatre
48 Elm Street
Brattleboro, Vermont 05301

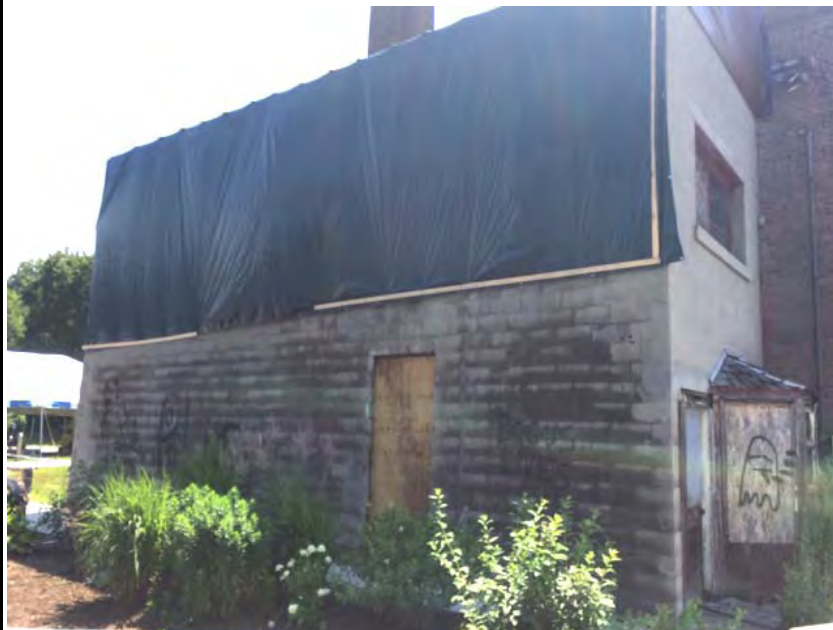
Photograph ID: 001
Date: July 2017
Location:
North and west sides of cinder block building addition.
Direction:
Looking south
Comments:

Showing the unpainted exterior surfaces of the cinder block building to be demolished.

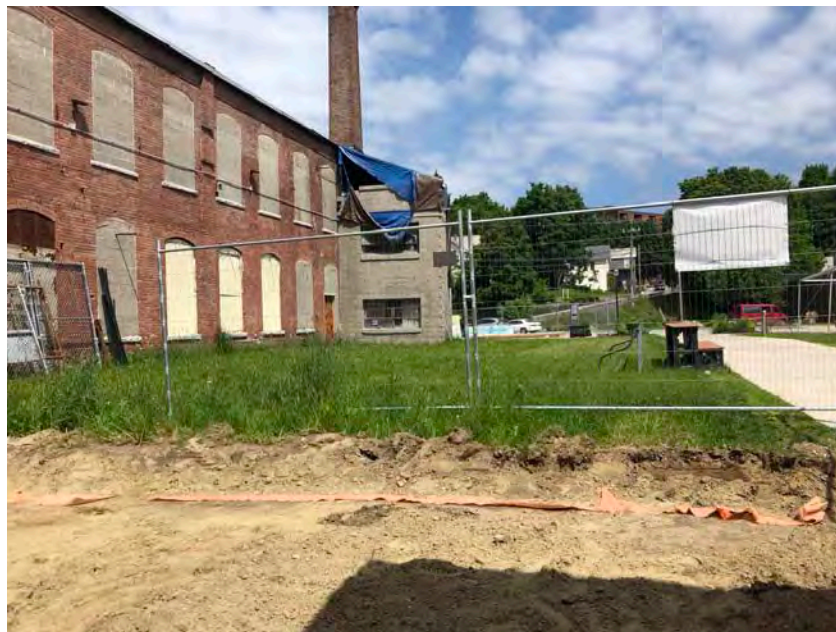
Photograph ID: 002
Date: May 2018
Location:
South side of cinder block building addition (right).
Direction:
Looking north
Comments:

Showing the unpainted exterior surface of the cinder block building to be demolished.

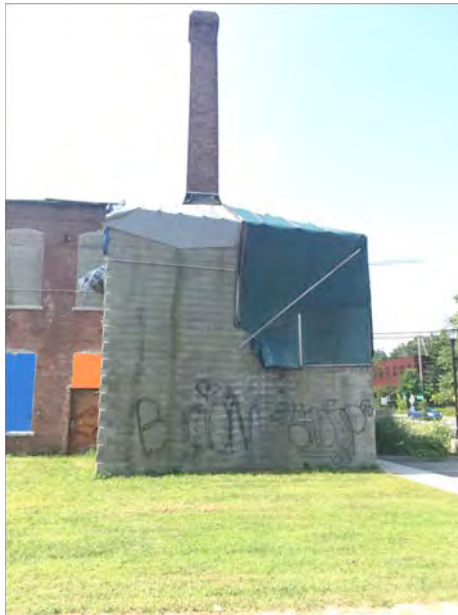
Photograph ID: 003
Date: August 2018
Location:
East side of cinder block building
addition
Direction:
Looking west
Comments:

Showing unpainted exterior
surface of the cinder block building
to be demolished.

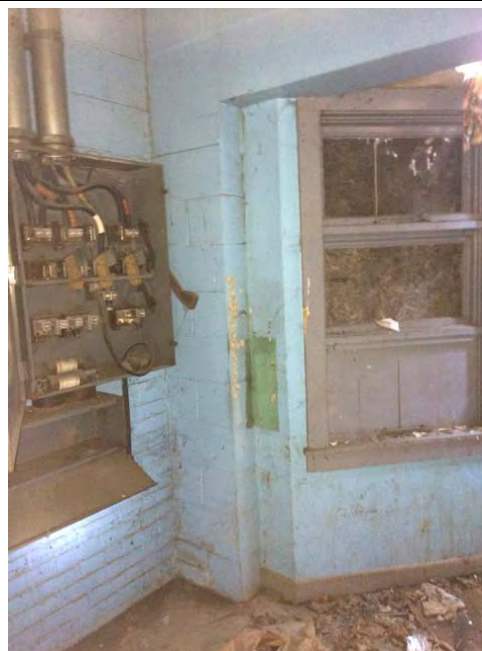
Photograph ID: 004
Date: August 2018
Location:
1W-5 Sampling Location
First floor-west wall
Direction:
Looking west
Comments:

1W-5 was a blue paint sample
collected in 2009 from the blue
painted cinder blocks (180 ppm
PCBs).

2. Light blue painted interior walls along the west ground floor block wall and the north ground floor block wall must be managed as Bulk Product Waste and Hazardous Waste to comply with State and Federal regulations.

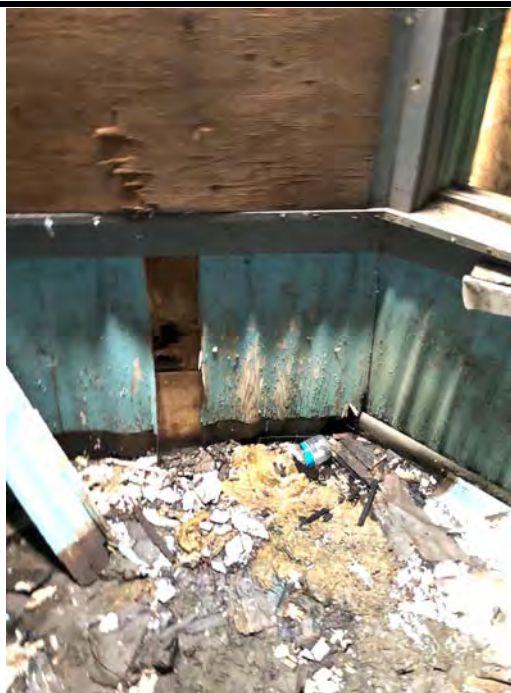
Photograph ID: 005
Date: August 2018
Location:
PS-101 sampling location
First floor - west wall
Direction:
Looking west
Comments:

PS-101 was a blue paint sample collected from the west interior wood wall (60 ppm PCBs).

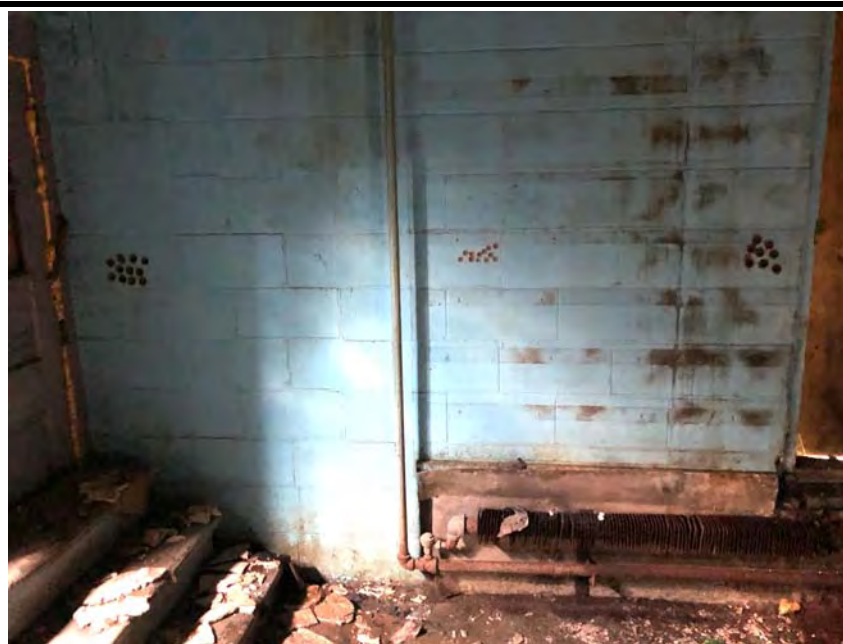
Photograph ID: 006
Date: August 2018
Location:
PS-102 Sampling Location
First floor-north wall
Direction:
Looking north
Comments:

PS-102 was a blue paint sample collected from the north interior wall (smaller diameter holes) (950 ppm PCBs).

The larger diameter holes on either side were from sample 1W-6, collected in 2009 (180 ppm PCBs).

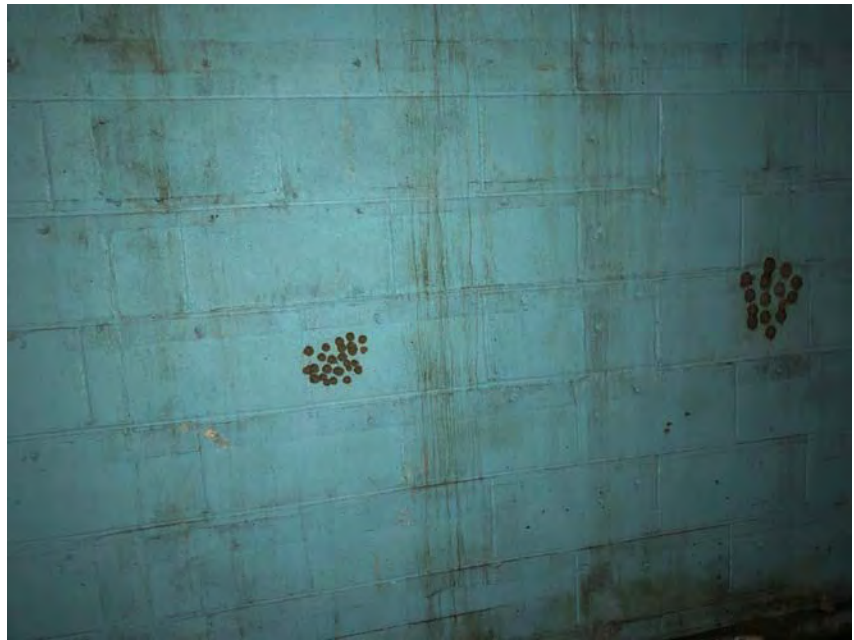
PS-103 was a blue paint sample collected from the north interior wall (smaller diameter holes) (3.5 ppm PCBs).

The larger diameter holes on the right were from sample 1W-7, collected in 2009 (0.6 ppm PCBs).

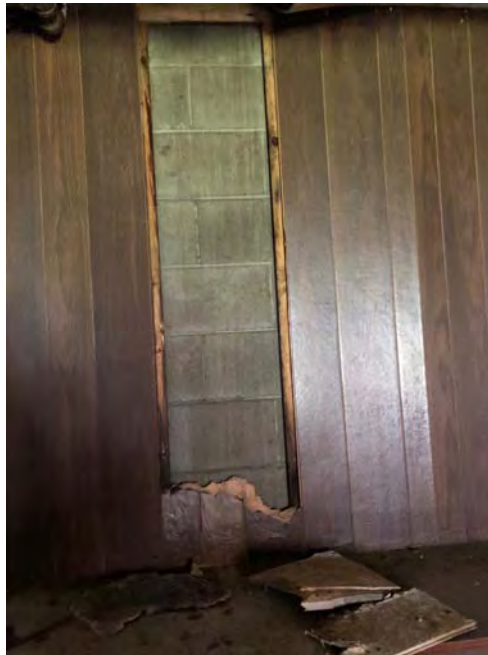
Photograph ID: 008
Date: August 2018
Location:
Intended PS-104 Sample Location
First floor-north wall
Direction:
Looking north
Comments:

Showing the intended sampling location for PS-104 on the north wall. Removing the paneling indicated the interior wall was not painted, therefore, PS-104 was relocated farther west in the blue painted zone.

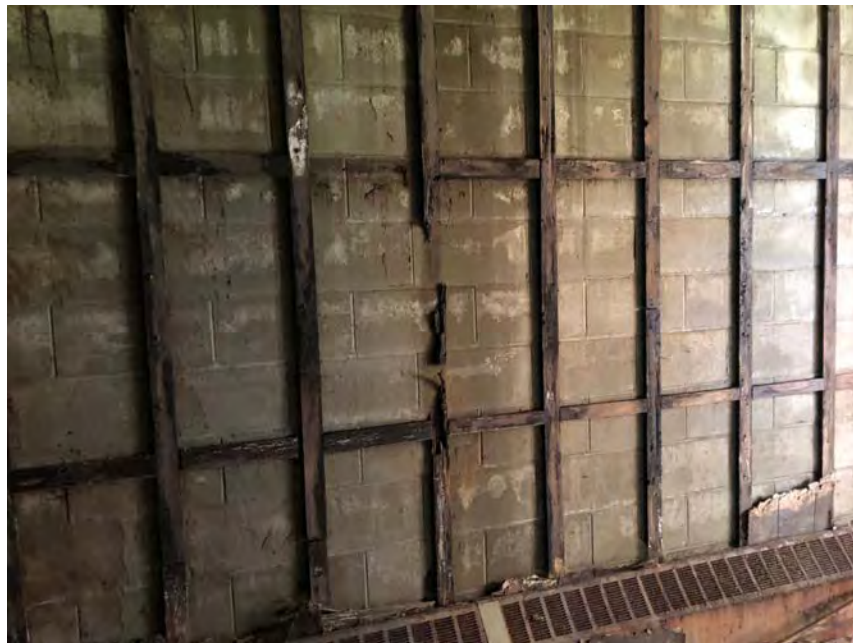
Photograph ID: 009
Date: August 2018
Location:
Intended PS-105 & 106 Sample
Locations-first floor east wall
Direction:
Looking east
Comments:

Showing the intended sampling
locations for PS-105 and PS-106
on the east wall. The interior wall
was not painted, therefore these
samples were not collected.

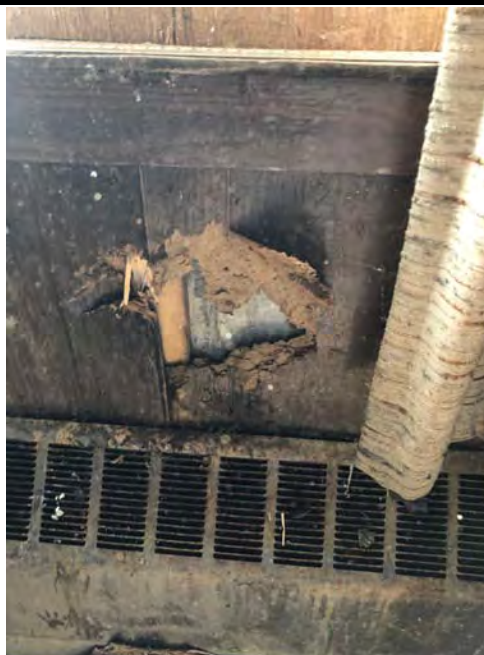
Photograph ID: 010
Date: August 2018
Location:
Intended PS-107 Sample Location
First floor-south wall
Direction:
Looking south
Comments:

Showing the intended sampling
location for PS-107. Pulling back
the wallboard in this zone indicated
that the cinder blocks were not
painted; therefore the sample
was not collected.

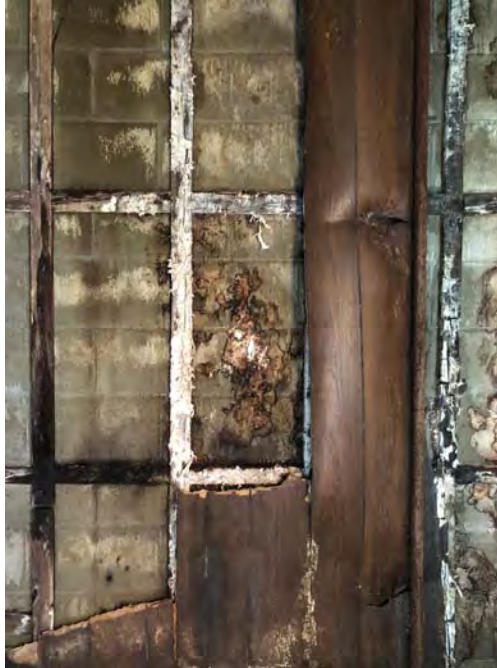
Photograph ID: 011
Date: August 2018
Location:
Intended PS-107 Sample Location
First floor-south wall
Direction:
Looking south
Comments:

Showing the intended sampling location for PS-107. Pulling back the wallboard in this zone indicated that the cinder blocks were not painted; therefore the sample was not collected.

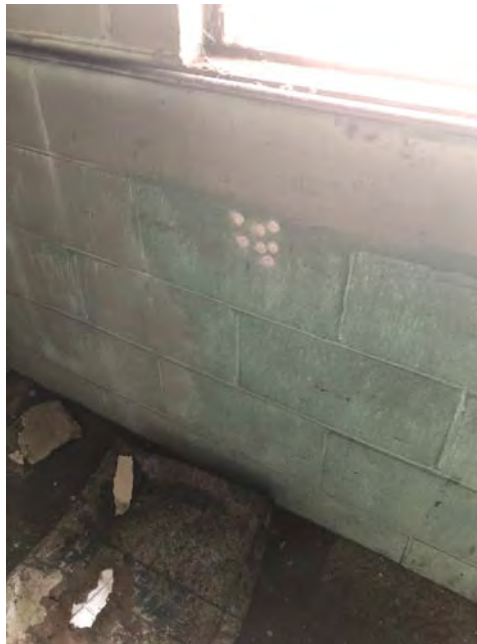
Photograph ID: 012
Date: August 2018
Location:
PS-108 Sample Location
Second floor- west wall
Direction:
Looking west
Comments:

PS-108 was a green paint sample collected from the west interior wall (1.4 ppm PCBs).

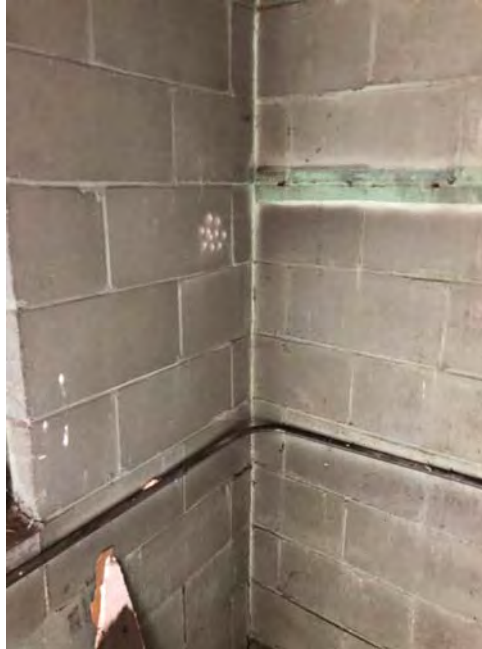
Photograph ID: 013
Date: August 2018
Location:
PS-109 Sample Location
Second floor-west wall
Direction:
Looking north
Comments:

PS-109 was a green paint sample collected from the west interior wall (2.4 ppm PCBs).

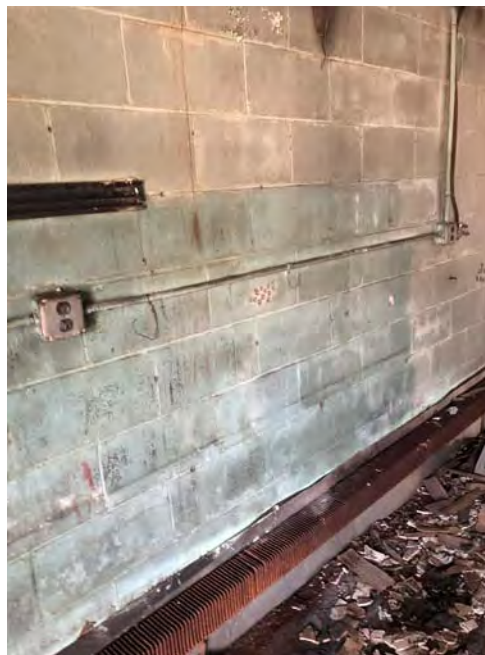
Photograph ID: 014
Date: August 2018
Location:
PS-110 Sample Location
Second floor-north wall
Direction:
Looking north
Comments:

PS-110 was a green paint sample collected from the north interior wall (2.0 ppm PCBs).

Sample holes from 2W-7 collected in 2009 are visible (0.5 ppm PCBs)

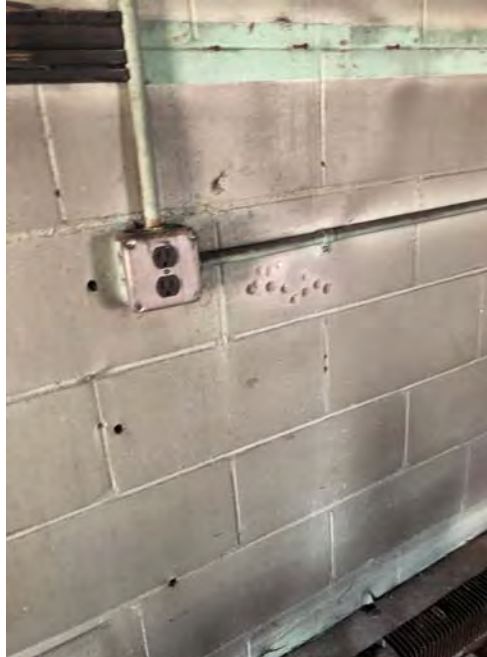
Photograph ID: 015
Date: August 2018
Location:
PS-111 Sample Location
Second floor-north wall
Direction:
Looking east
Comments:

PS-111 was a grey paint sample collected from the north interior wall (3.3 ppm PCBs). The sample holes for 2W-8 collected in 2009 are visible (0.5 ppm PCBs).

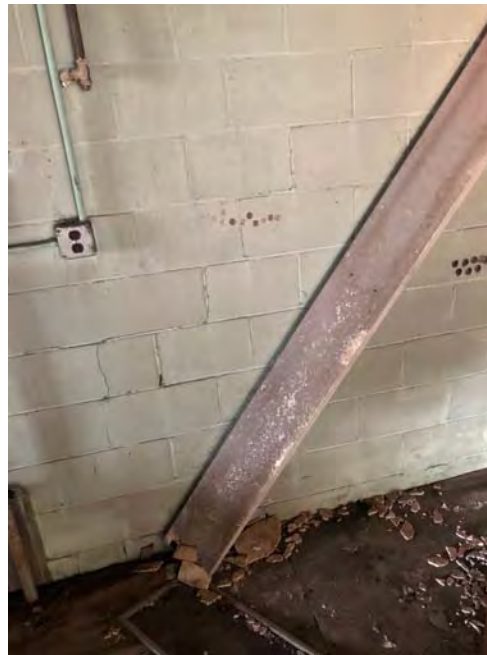
Photograph ID: 016
Date: August 2018
Location:
PS-112 Sample Location
Second floor-north wall.
Direction:
Looking north
Comments:

PS-112 was a grey paint sample collected from the north interior wall (2.0 ppm PCBs). Holes for 2W-9 collected in 2009 are visible to the right (0.6 ppm PCBs).

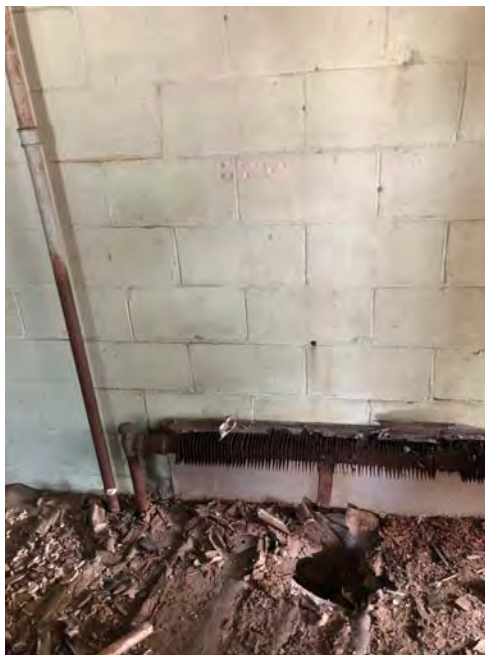
Photograph ID: 017
Date: August 2018
Location:
PS-113 Sample Location
Second floor east wall
Direction:
Looking east
Comments:

PS-113 was a green paint sample collected from the east interior wall (2.3 ppm PCBs).

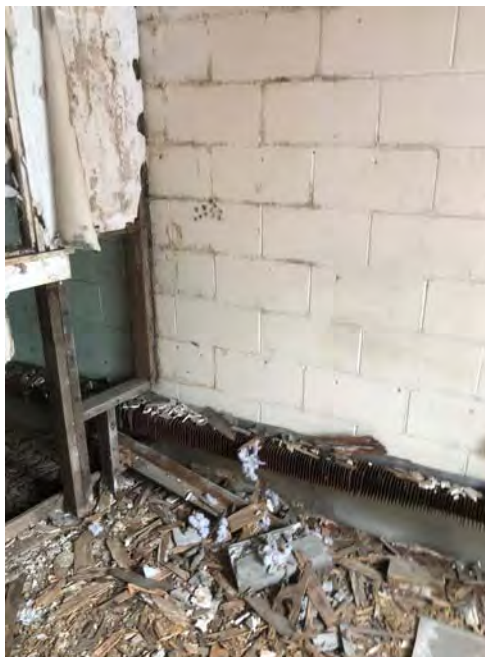
Photograph ID: 018
Date: August 2018
Location:
PS-114 Sample Location
Second floor-east wall
Direction:
Looking east
Comments:

PS-114 was a tan paint over green paint sample from the east interior wall (3.1 ppm PCBs).

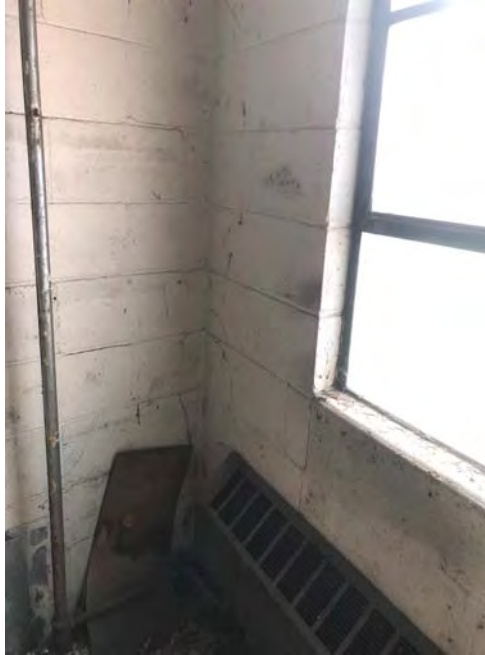
Photograph ID: 019
Date: August 2018
Location:
PS-115 Sample Location
Second floor-south wall
Direction:
Looking east
Comments:

PS-115 was a tan paint over green paint sample from the south east corner interior wall (3.0 ppm PCBs).

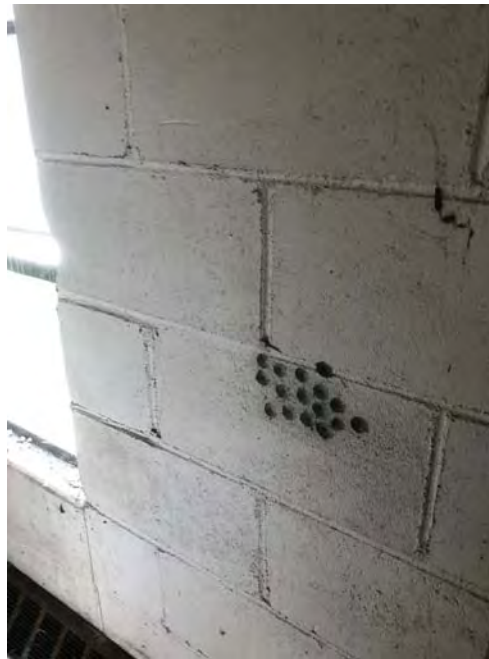
Photograph ID: 020
Date: August 2018
Location:
PS-116 Sample Location
Second floor-south wall
Direction:
Looking south
Comments:

PS-116 was a tan paint over green paint sample from the south interior wall (3.5 ppm PCBs)

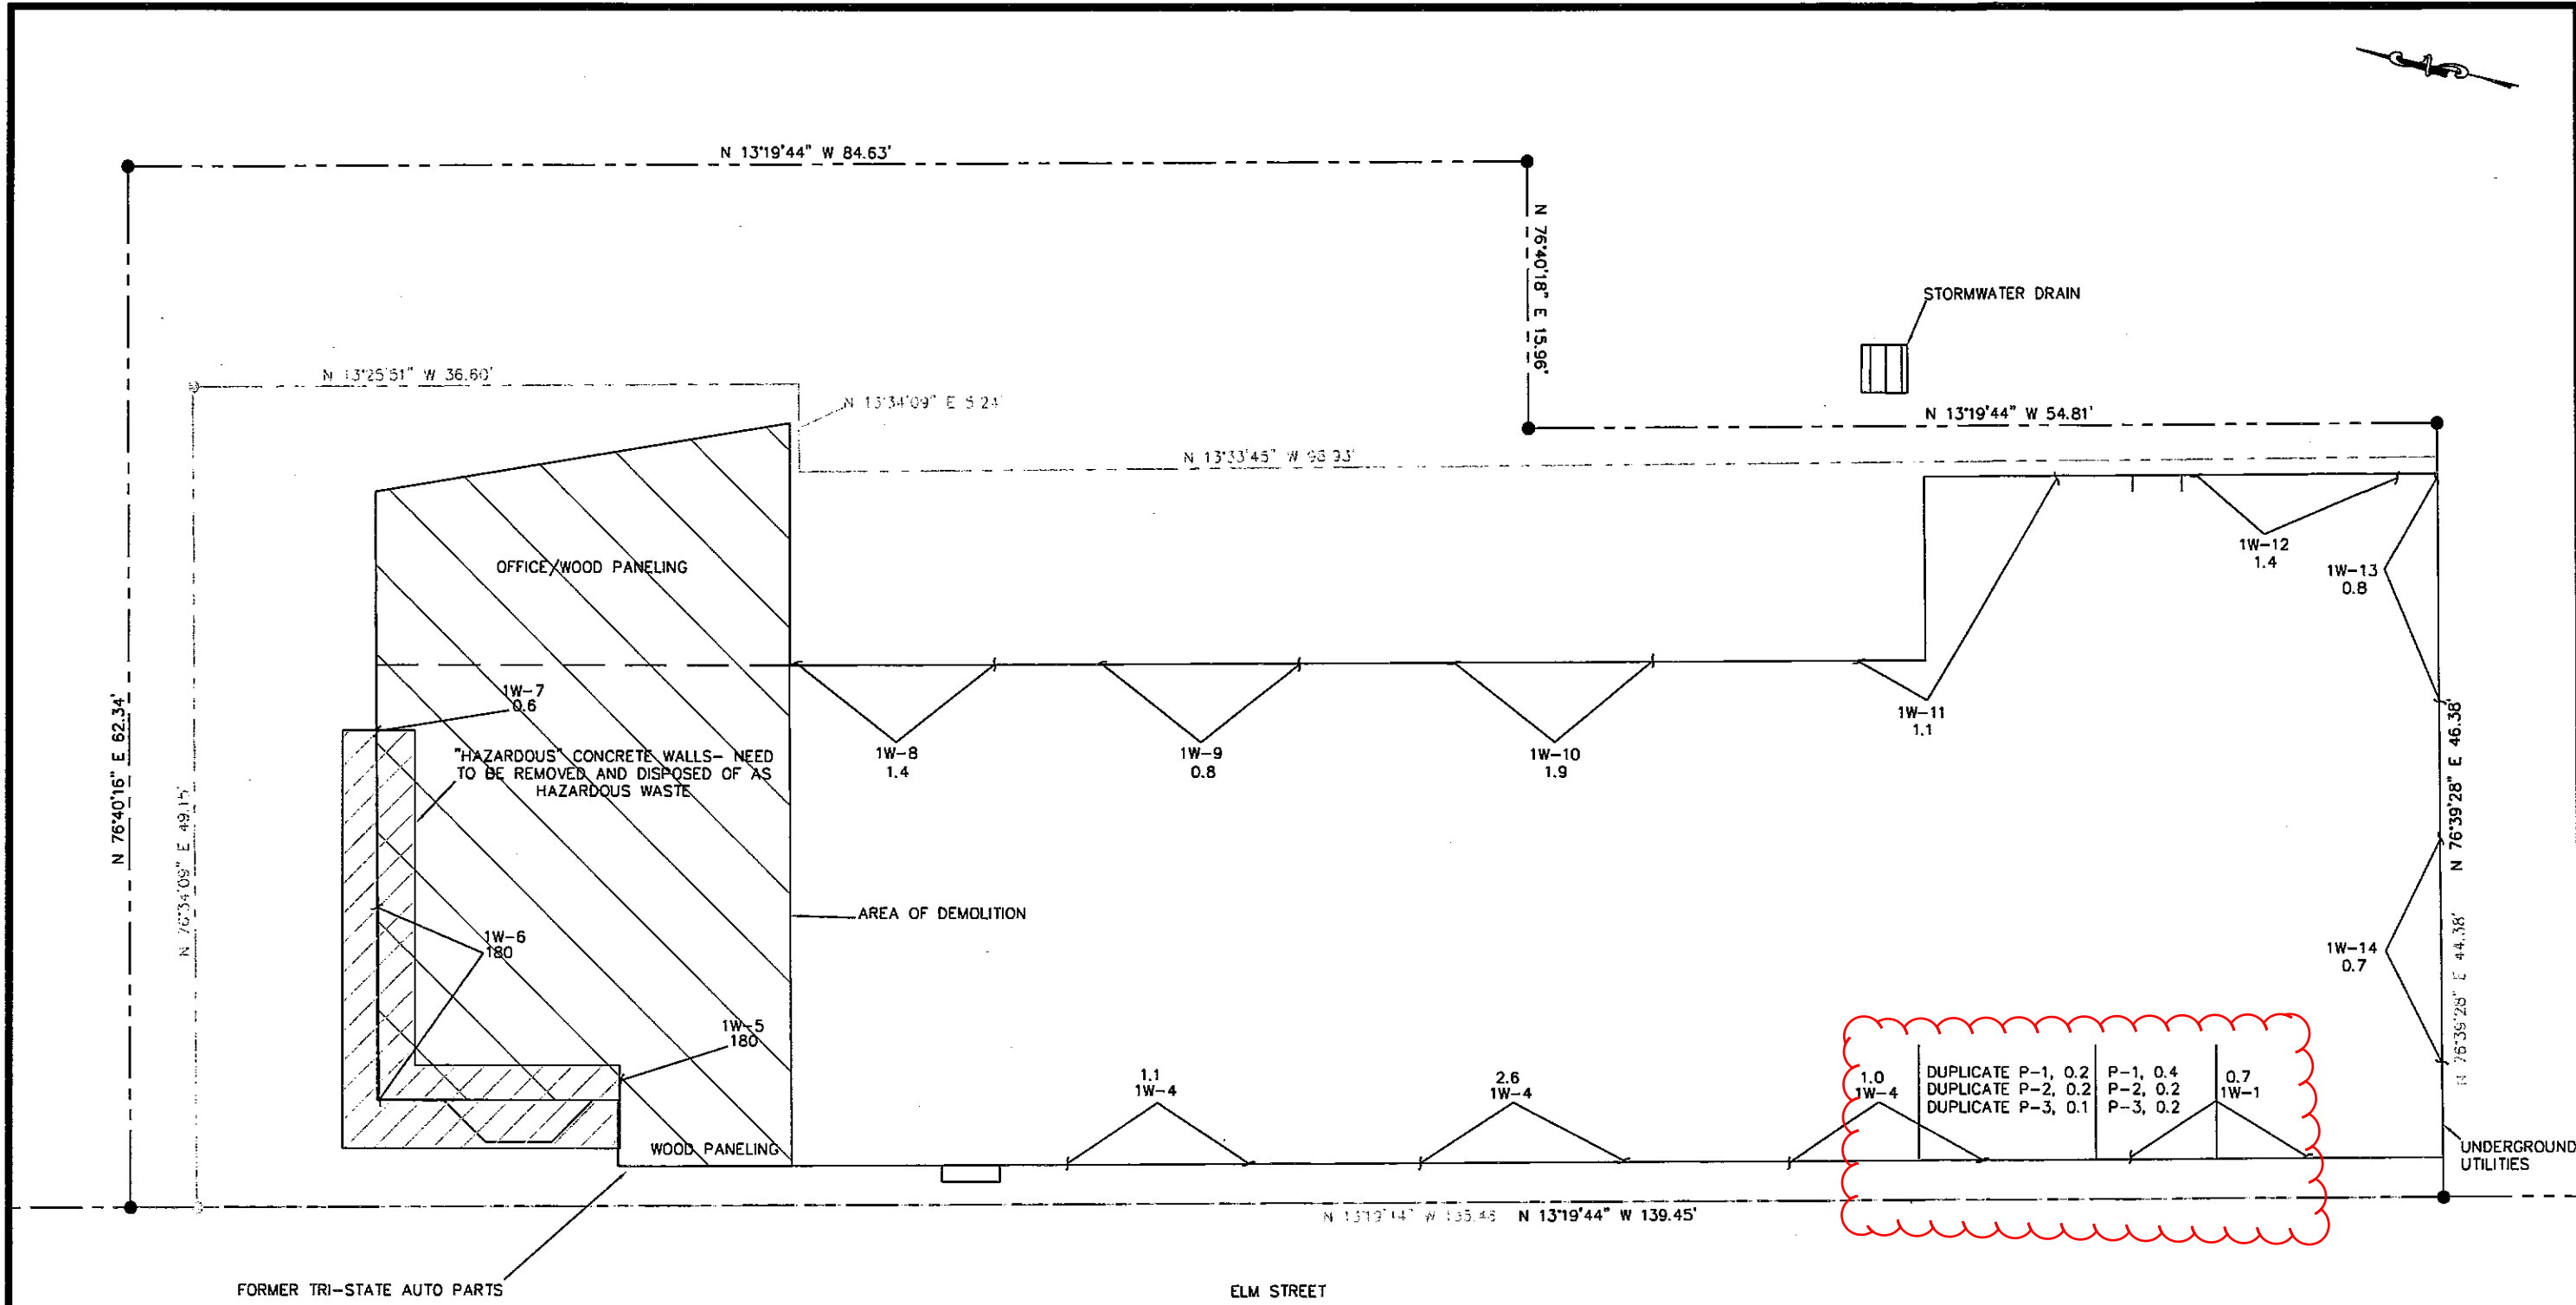
Five masonry profiling samples were collected in the vicinity of the “hot spot” on the basement wall on September 10, 2009. One duplicate sample was also collected. Samples were collected in accordance with the USEPA Region 1 Sampling Concrete in the Field, Revision 0.0, December 1997. Sampling equipment was decontamination between each sample. The samples were containerized and delivered to Eastern Analytical, Inc for laboratory testing of PCBs via EPA Method 8082. The sample locations are shown on the attached Site map. Tabulated results

1.0 1W-4	DUPLICATE P-1, 0.2 DUPLICATE P-2, 0.2 DUPLICATE P-3, 0.1	P-1, 0.4 P-2, 0.2 P-3, 0.2	0.7 1W-1
-------------	--	----------------------------------	-------------
